# A literature review: The nature of partial discharges in stator insulation

Nathaniel Taylor , ETK, KTH

September 2008

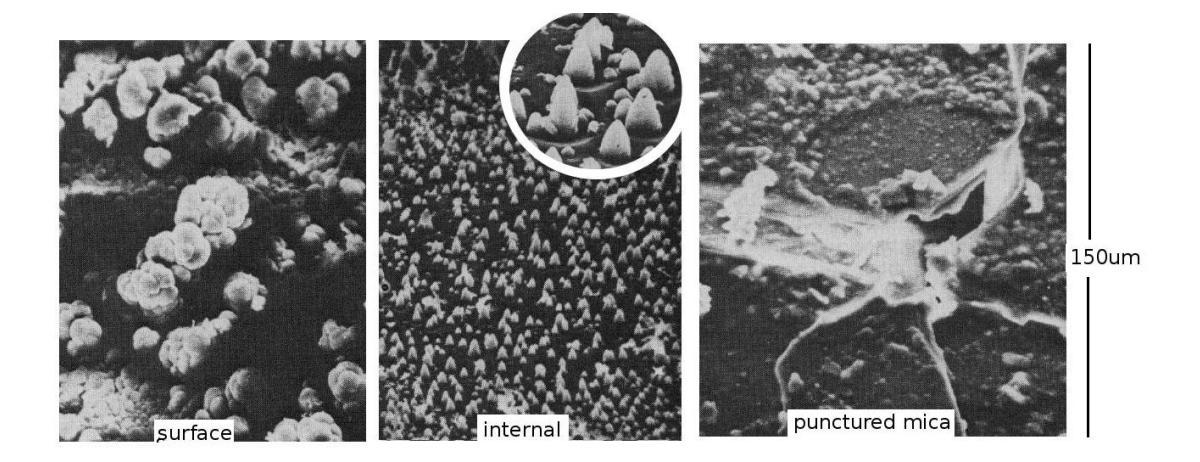
Figure 2: Electron micrographs of PD-induced changes on micaceous insulation. At the left, deposits on external surfaces; in the centre, deposits on internal surfaces, including a close-up; at the right, a puncture through a mica flake. All main pictures are to approximately the same scale, the height of the image being  $\sim 150 \,\mu\text{m}$ . From [Woo73], combining several images.

Dendritic deposits (figure 2) from the PD were analysed: regardless of whether muscovite or phlogopite mica was used, the deposits from surface discharge were seen to be silica, and those from the cavities were seen to be the same composition as the mica (containing Al or Mg as well as Si). It seems therefore that both sorts of deposit come from mica, not from the epoxy.

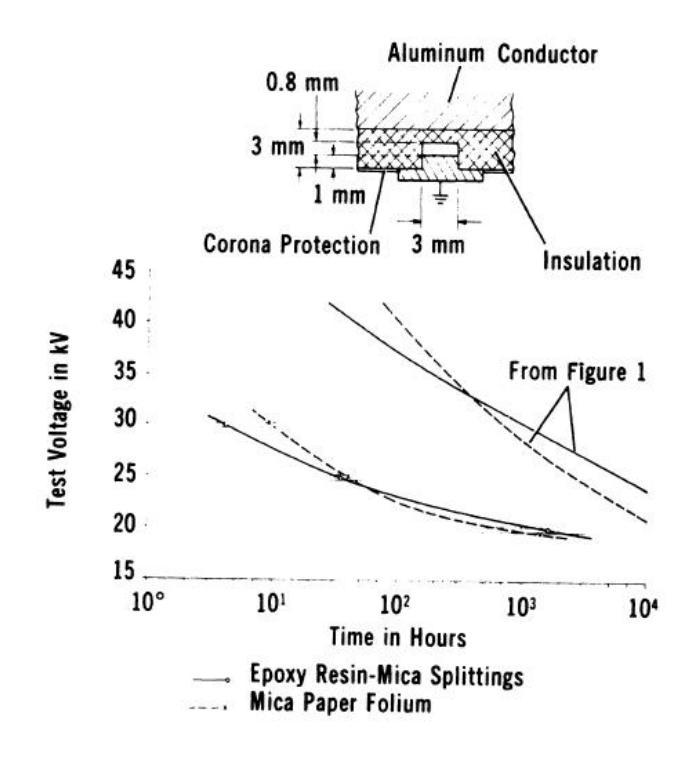
Figure 3: times to 50% failure for varied voltage at 1.2 kHz; 'from figure 1' is similar objects without the added PD source of the cavity shown above. From [Wic77].

all cases) of the time t to breakdown at field E, with k being between 25 kV/mm and 30 kV/mm and  $\alpha$  being about 3 to 4 kV/mm per decade of t.

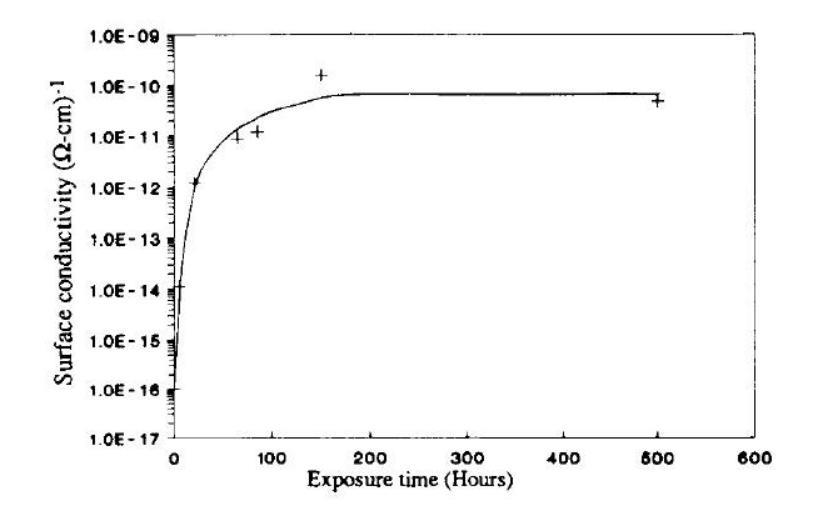
**Figure 4:** 'Surface conductivity' (meaning?) of epoxy specimens, dependent on time of exposure to PD in a sealed cell. From [Hud90].

Unaged specimens had lower than  $10^{-16}$  S surface conductivity (the detection limit); specimens aged for 500 hours had about  $10^{-10}$  S; specimens aged for at least 100 hours had a similarly high surface conductivity regardless of whether they were removed from the aging while showing a large or small discharge intensity, the small intensity being generally the final state; a sample that had attained a low intensity after only 5 hours (figure 5) was measured at 20 hours and found to have still a low conductivity of  $10^{-14}$  S/cm. The (mean) surface conductivity and measured average amplitude are not strongly related!

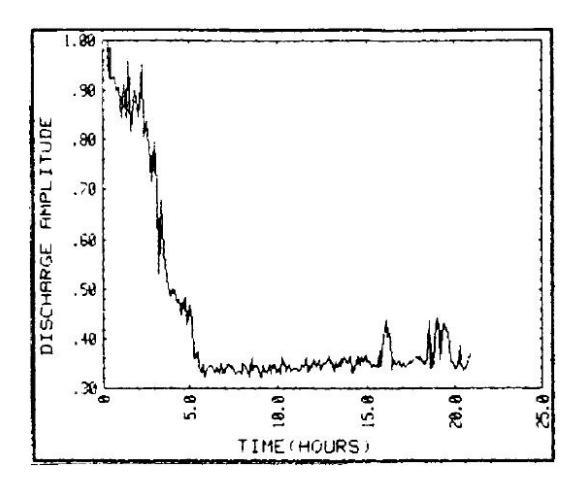
Figure 5: Time-development of normalised discharge amplitude, for a specimen which took only a few hours to reach a steady low value. From [Hud90].

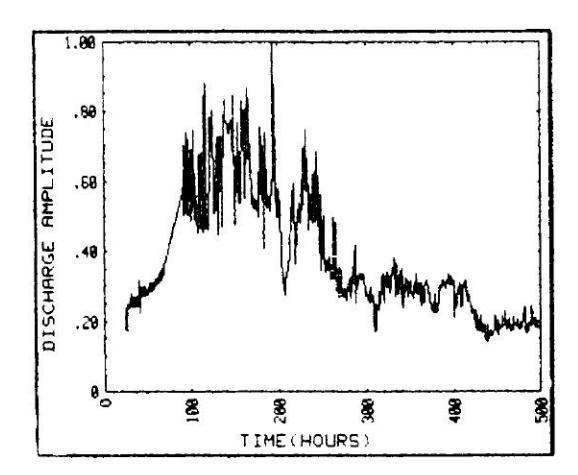
Figure 6: Time-development of normalised discharge amplitude, for a specimen which took hundreds of hours to reach a steady low value; note that this value is rather lower than that in figure 5. From [Hud90].

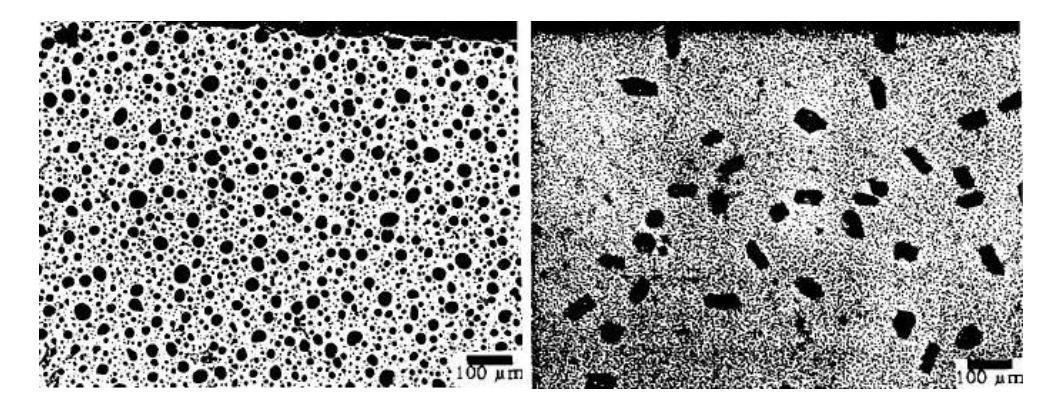
Figure 7: Microscope images, approximately 70 times larger than life (see the scale, bottom right), of the epoxy surface after exposure to PD. On the left, 'drops' after short exposure (hours, tens of hours?); on the right, 'crystals' after long exposure (hundreds of hours?). From [Hud90].

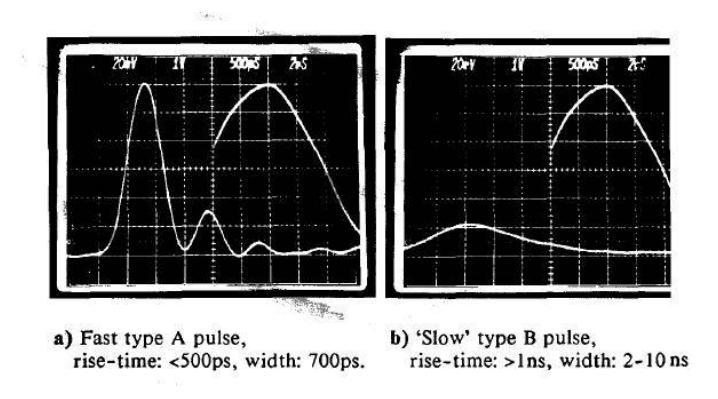
Figure 8: 'Fast and slow' pulse currents. The extra curves are supposed to be sines starting at the phase of the applied voltage at which the pulse occurred (clearly not in the same timescale). From [Hol91]

Two clearly distinguished classes of discharge pulse were seen: 'fast' ('A') pulses had a rise-time of less than 500 ps and width of 700 ps, and nearly constant maximum pulse size; 'slow' ('B') pulses had a rise-time of more than 1 ns, width of 2 ns to 10 ns, and magnitude variable but always about 5 to 100 times smaller than that of the fast pulses (assuming the quoted dB values were in amplitude, not power). Figure 8 shows the time-domain currents for examples of the two types.

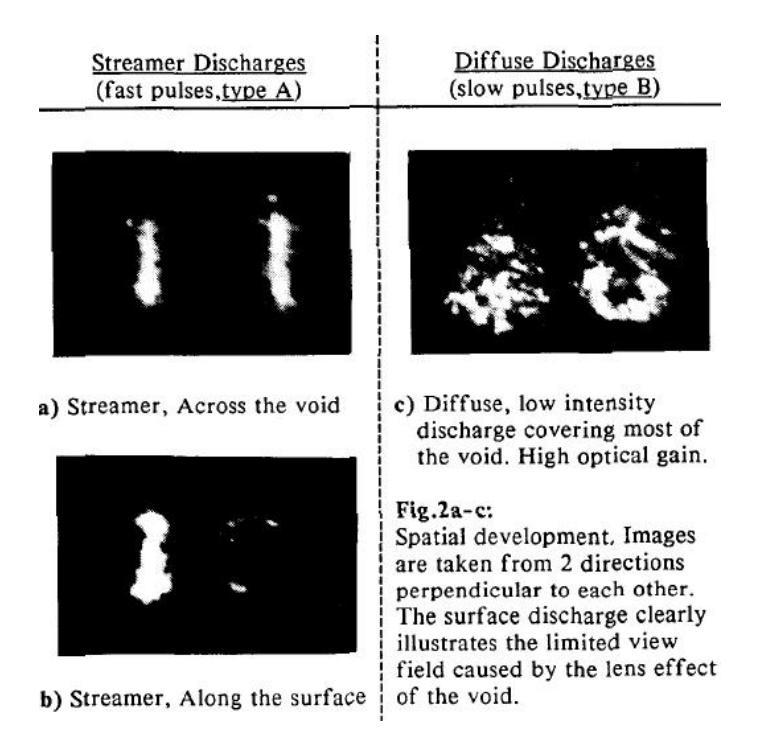
Figure 9: Spatial resolution (two angles each) of different discharges in a 3.5 mm diameter spherical cavity in epoxy. From [Hol91]

The optical measurements showed streamer-like and diffuse discharges, corresponding to the fast and slow measured pulses, as shown in space and time in figures 9 and 10. These are at 19 kV applied voltage, but under X-ray irradiation to provide start-electrons the inception was at 6 kV; this means there is a large over-voltage available, which may

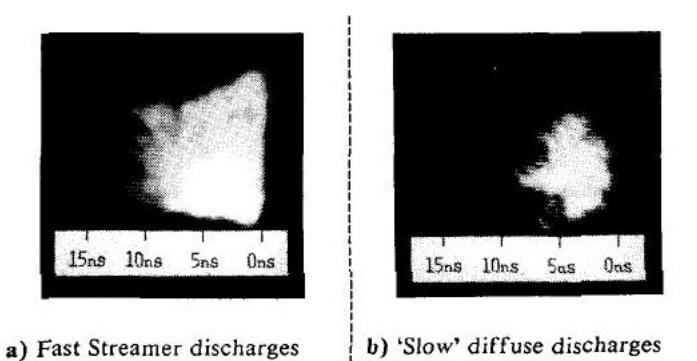
Figure 10: Time-developmet of two discharges in a 3.5 mm diameter spherical cavity in epoxy. From [Hol91]

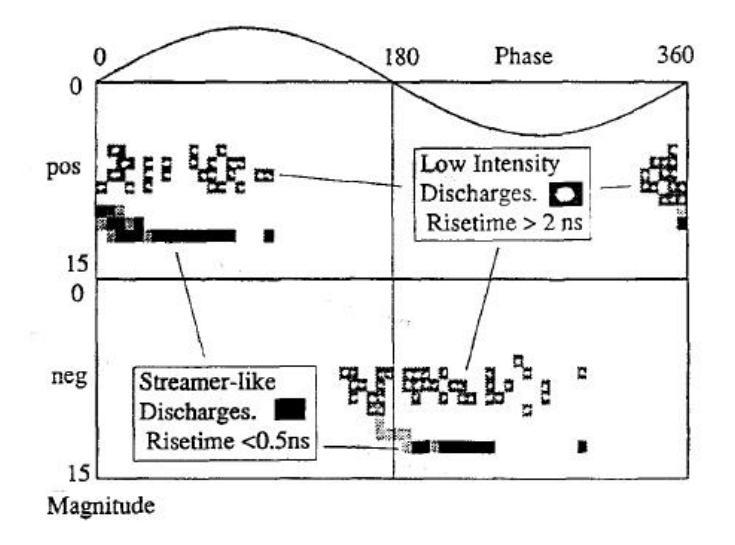
**Figure 11:** Phase-resolved PD pattern, including the slow and fast pulses. (Note how + and – parts have the same orientation, upside-down.) The streamers have much larger pulse size. From [Hol91]

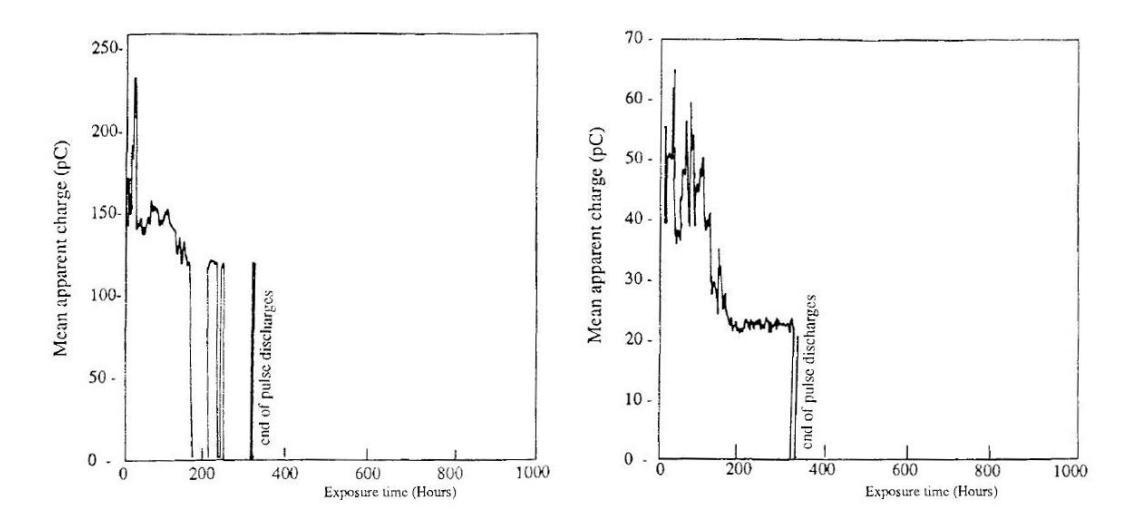
**Figure 12:** Time development of (mean) PD amplitudes, considering charges above 100 pC (left) and above 20 pC (right). From [Hud93].

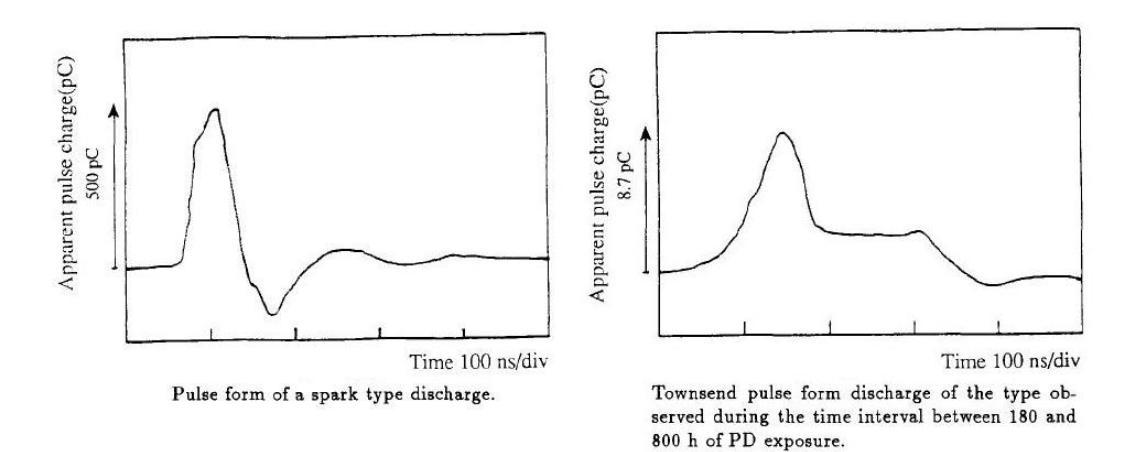
Figure 13: PD pulse waveforms for the early-stage large spark-type discharge and the later-stage smaller, slower discharge. From [Hud93].

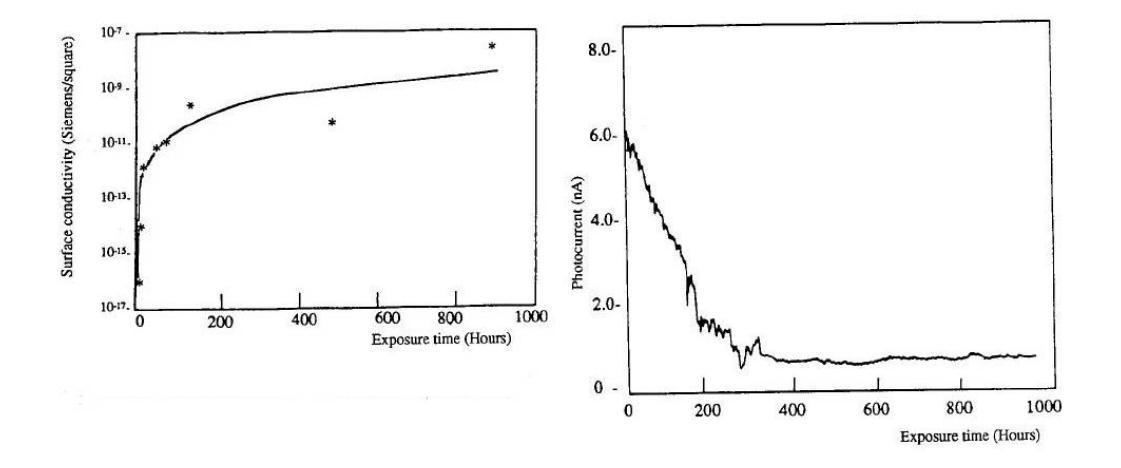
Figure 14: Surface conductivity and photomultiplier current due to emissions from the PD (note that the  $\sim 0.4$  nA final value is some 100 times the dark value). From [Hud93].

Photomultiplier current, at the right of figure 14, is much higher initially, in the presence of some large spark discharges, but definitely continues at a very constant level, not changing significantly at the times at which the >20 pC then >0.5 pC PDs were seen in figure 12 to cease; this points to a glow or very small-pulse pseudo-glow discharge. The conductivity, at the left of figure 14, rises sharply at the very beginning, in some ten or so hours, and thenafter increases quite gradually; this suggests that the glow is not much less effective than the pulsed PD at causing changes on the surface. (But, how were conductivity points obtained, and how many are there; they were presumably from different specimens, and specimens are acknowledged as having very different times to particular states of PD; there are also not many points shown — about seven are visible in this plot.)

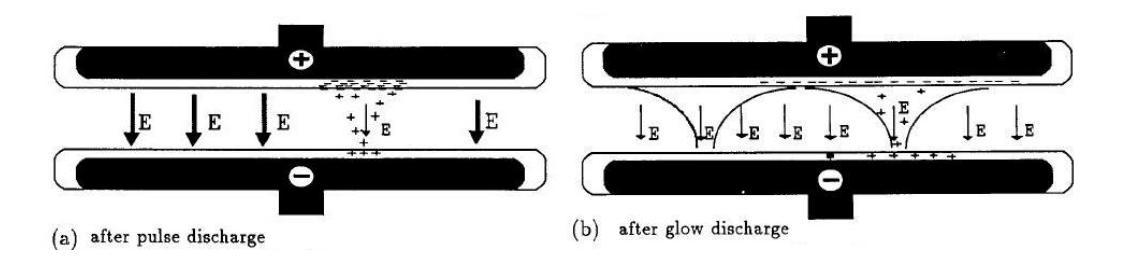
Figure 15: Cavity electric field after the two types of discharge. (Not at all to scale, even in vertical direction alone.) From [Hud93].

In the later stages of discharge — Townsend-like pulses, and glow — the cavity voltage is held close to the inception voltage; new (pulse) or increased (glow) discharges occur easily when the voltage across the cavity rises, until the extra charge on the dielectric barriers has compensated the change in voltage. In the earlier stages — spark-like pulses — the cavity voltage can often rise to much greater values than the inception voltage, due possibly to lack of initial electrons or electronegativity of oxygen in the gas; when a discharge does start, the strong local electric field can cause a strongly ionising discharge that reduces the local electric field to much less than the inception value; the electric field in different parts of a cavity can vary, due to low surface conductivity. Figure 15 gives a diagrammatic view of this distinction.

Figure 15 shows the suggested influence of surface conductivity on discharge development: the point from that 1971 reference is shown here, that in a glow discharge the 'remnant' voltage across the cavity stays close to the breakdown value, while with the spark discharge the remnant voltage (in a more confined area) collapses to a lower value than the breakdown voltage.

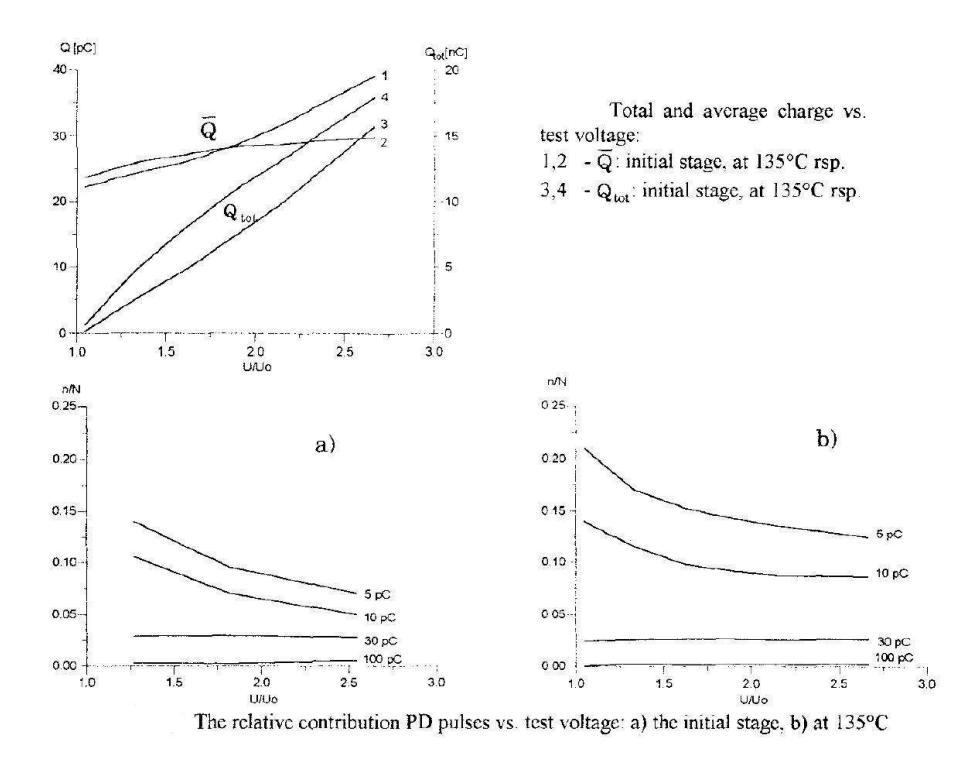
Figure 18: PD charge-distributions related to inception voltage  $U_0$ . From [Flo95a].

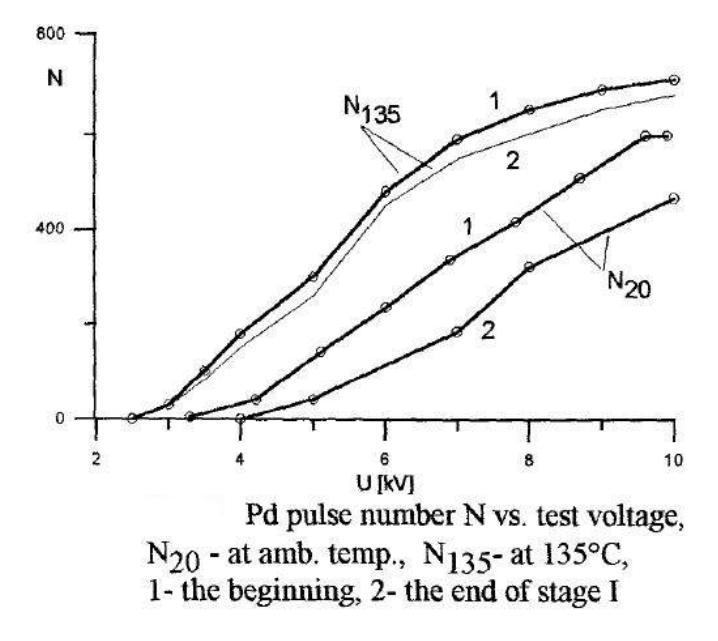
Figure 19: Changes due the stage-I aging, shown at two temperatures. The change with temperature is the more interesting point! From [Flo95b]

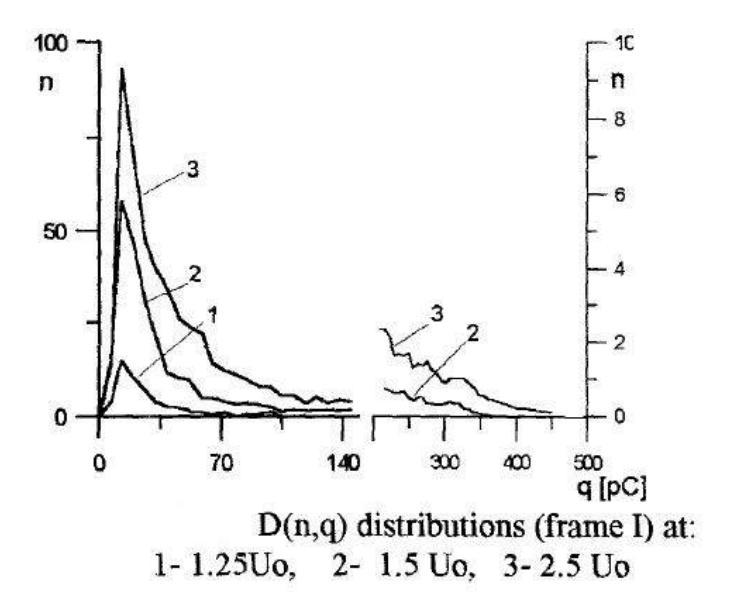
Figure 20: Voltage-dependence of D(n,q).  $U_{\rm O}$  denotes PDIV. From [Flo95b]

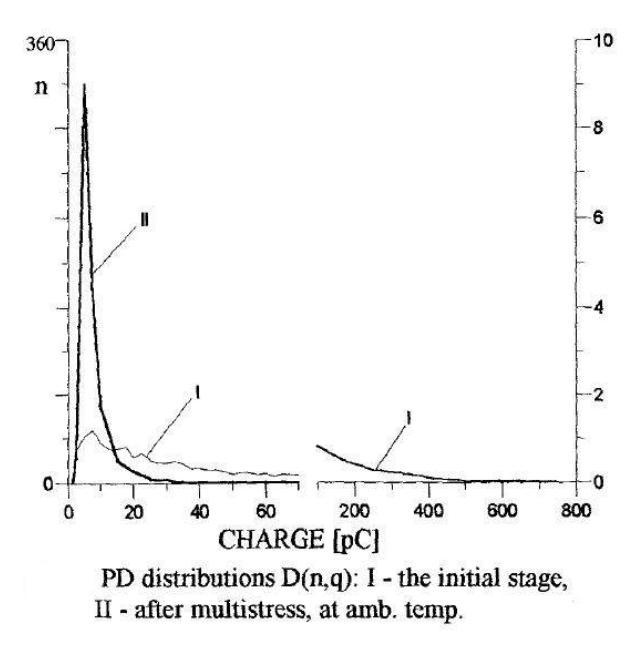
Figure 21: Effect of long-term aging on distribution of PD magnitudes. From [Flo95b].

Measurements at 20 °C before and after the long aging showed a large change in the shape of the PD distribution, with more of the small PDs (see figure 21), and a reduction

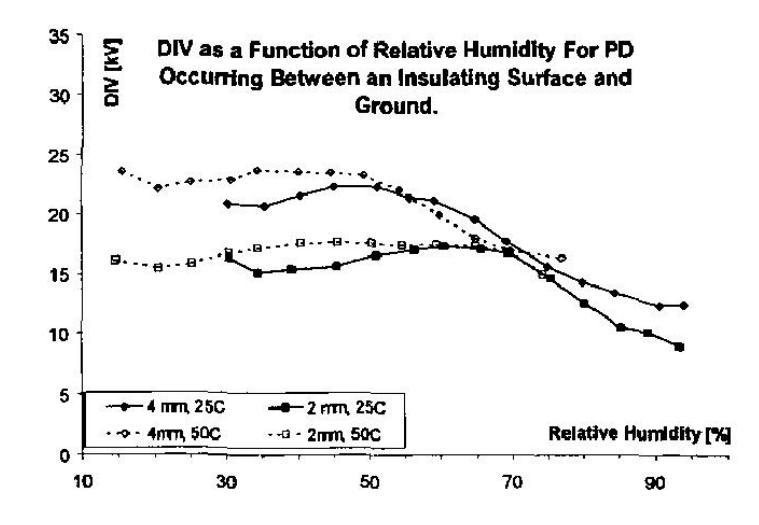
Figure 23: Insulator-plane PDIV, with varied humidity at 25 °C and 50 °C. From [Fen03].

Figures 22 and 23 show the change in PDIV for the two configurations of electrodes, each plotted against relative humidity (RH) for varied temperature and gap. The peaks in the PDIV are at around 50 % RH; the change in PDIV over the humidities below this peak (where increased electronegative 'gas' is claimed as the dominant influence) is really quite small — perhaps ten percent — while the change due to the high humidities (where surface droplets are blamed for the change) is more than a factor of two.

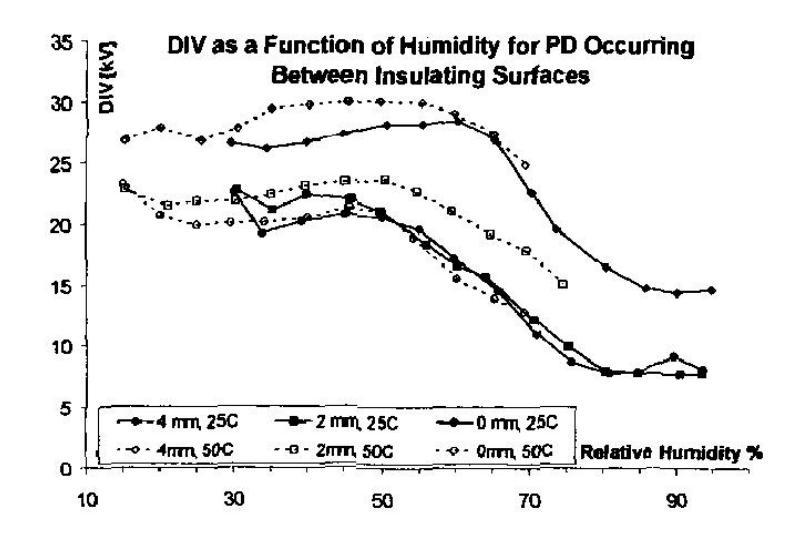
Figure 22: Insulator-insulator PDIV, with varied humidity at 25 °C and 50 °C. From [Fen03].

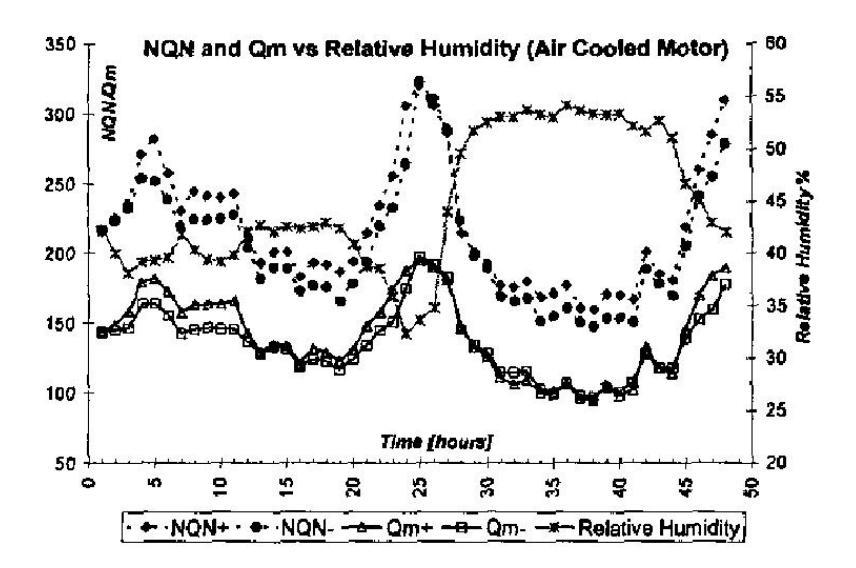
Figure 24: Relation of PD to humidity for an operating machine over two days. From [Fen03]

It is also interesting to note the relation of a real machine's PD activity to the (relative) humidity, when monitored over two days of operation (figure 24).
